Navajo Abandoned Uranium Mine

Site Screen Report

Evans Huskon No. 35 AUM Site

January 2011

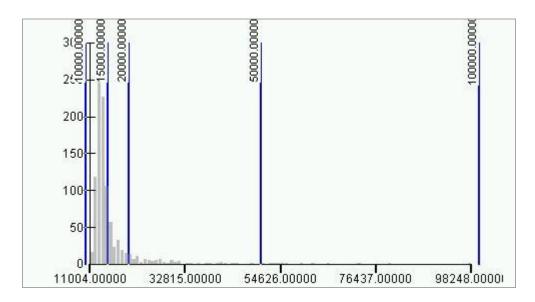
A total of 987 gamma radiation measurements were collected from the mine site, ranging from 11,004 cpm to 98,248 cpm. The measurements collected at one of the mounds were found at a maximum level of approximately 95,000 cpm. The measurements are represented in Figures 1 and 2.

Distribution Chart and Statistics:

The following chart and statistics were generated by ESRI ArcGIS 9.3.1, and show the general distribution of the site gamma radiation measurements. The horizontal X axis represents the gamma radiation reading levels in cpm (lowest levels to the left). The vertical Y axis represents the frequency of each gamma radiation level.
